**KOMITE NASIONAL KESELAMATAN TRANSPORTASI
REPUBLIC OF INDONESIA**

KNKT.18.10.35.04

Aircraft Accident Investigation Report

**PT. Lion Mentari Airlines
Boeing 737-8 (MAX); PK-LQP
Tanjung Karawang, West Java
Republic of Indonesia
29 October 2018**

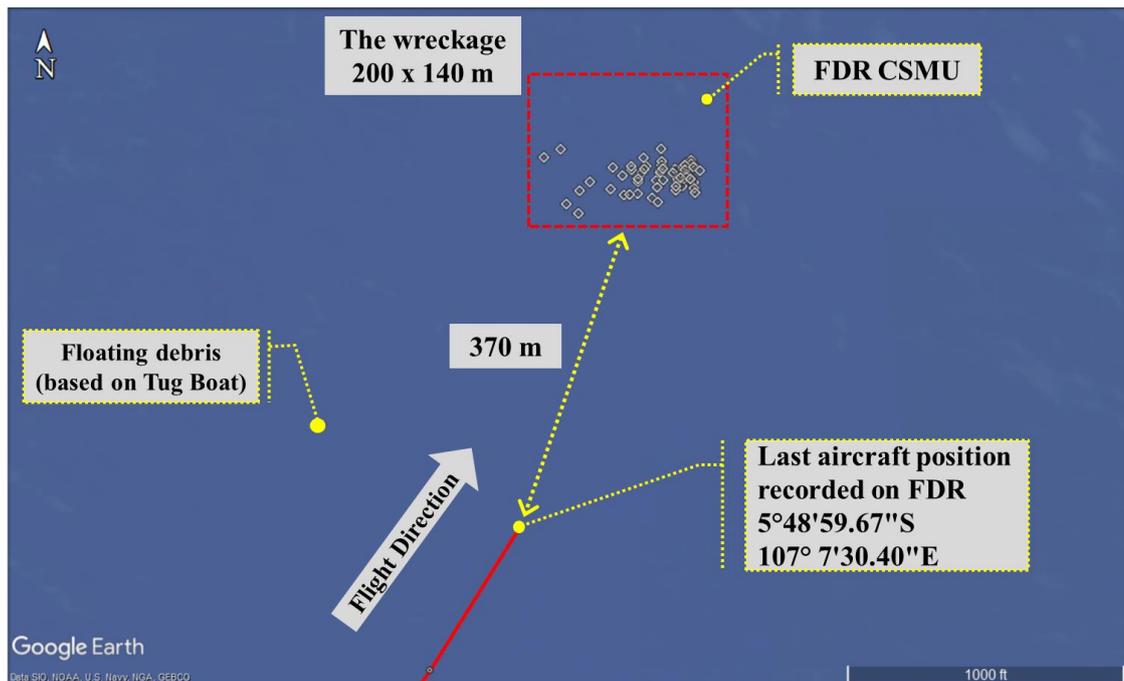
Figure 8: The wreckage distribution

The CSMU was found at 5°48'43.20"S 107°7'37.60"E which was within the wreckage distribution area. Several parts of the aircraft were recovered and transported to Jakarta International Container Terminal (JICT). The wreckage recovered was from all parts of the aircraft from the forward part to the aft part.

The recovered wreckage identified consisted of, but not limited to, the left and right engines, both main landing gears, parts of the empennage, parts of the forward and aft left passenger doors, parts of the wings, a flight crew oxygen bottle, and parts of a circuit breaker panel.

The damage to the aircraft suggested a high energy impact.
