**KOMITE NASIONAL KESELAMATAN TRANSPORTASI
REPUBLIC OF INDONESIA**

KNKT.18.10.35.04

Aircraft Accident Investigation Report

**PT. Lion Mentari Airlines
Boeing 737-8 (MAX); PK-LQP
Tanjung Karawang, West Java
Republic of Indonesia
29 October 2018**

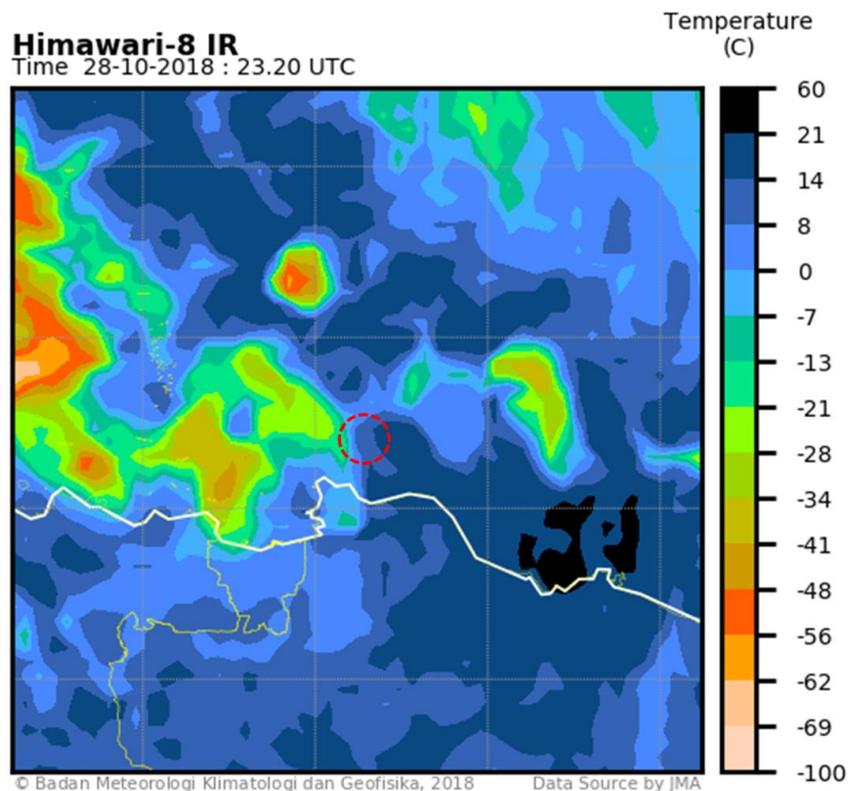
The *Badan Meteorologi Klimatologi dan Geofisika* (BMKG – Bureau of Meteorology, Climatology and Geophysics) provided enhanced infrared satellite images. The enhanced infrared satellite images at 2320 UTC (0620 LT) up to 2330 UTC (0630 LT) indicated that the temperature at the accident site (red circle) was from 0 up to 8°C.

Figure 1: Enhanced infrared satellite image at 2320 UTC (0620 LT)

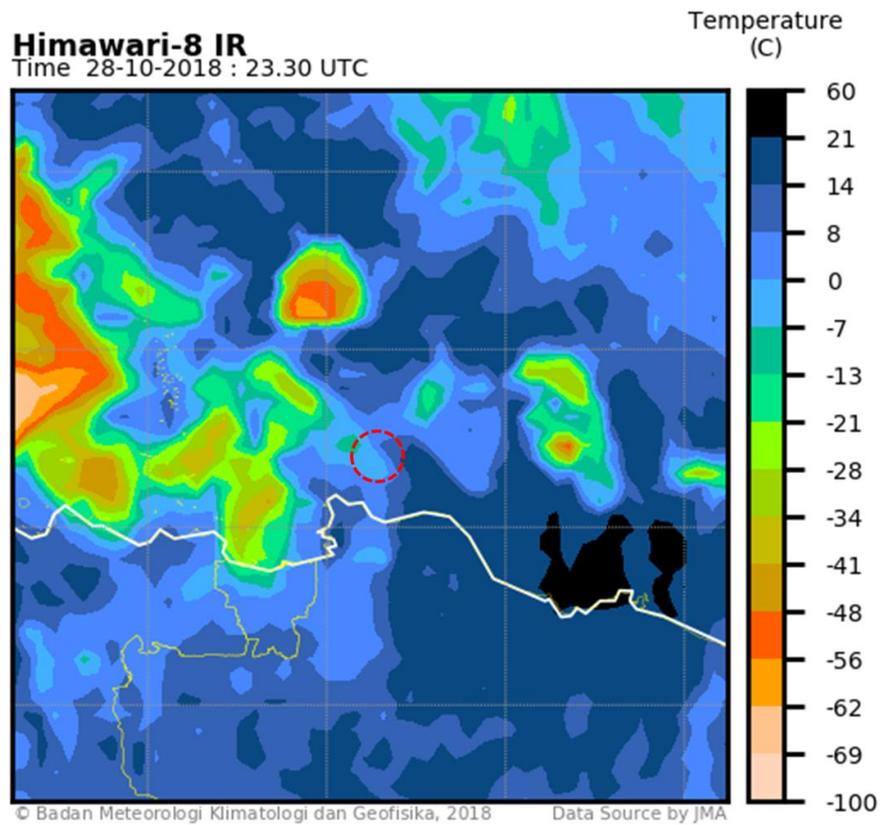
Figure 2: Enhanced infrared satellite image at 2330 UTC (0630 LT)

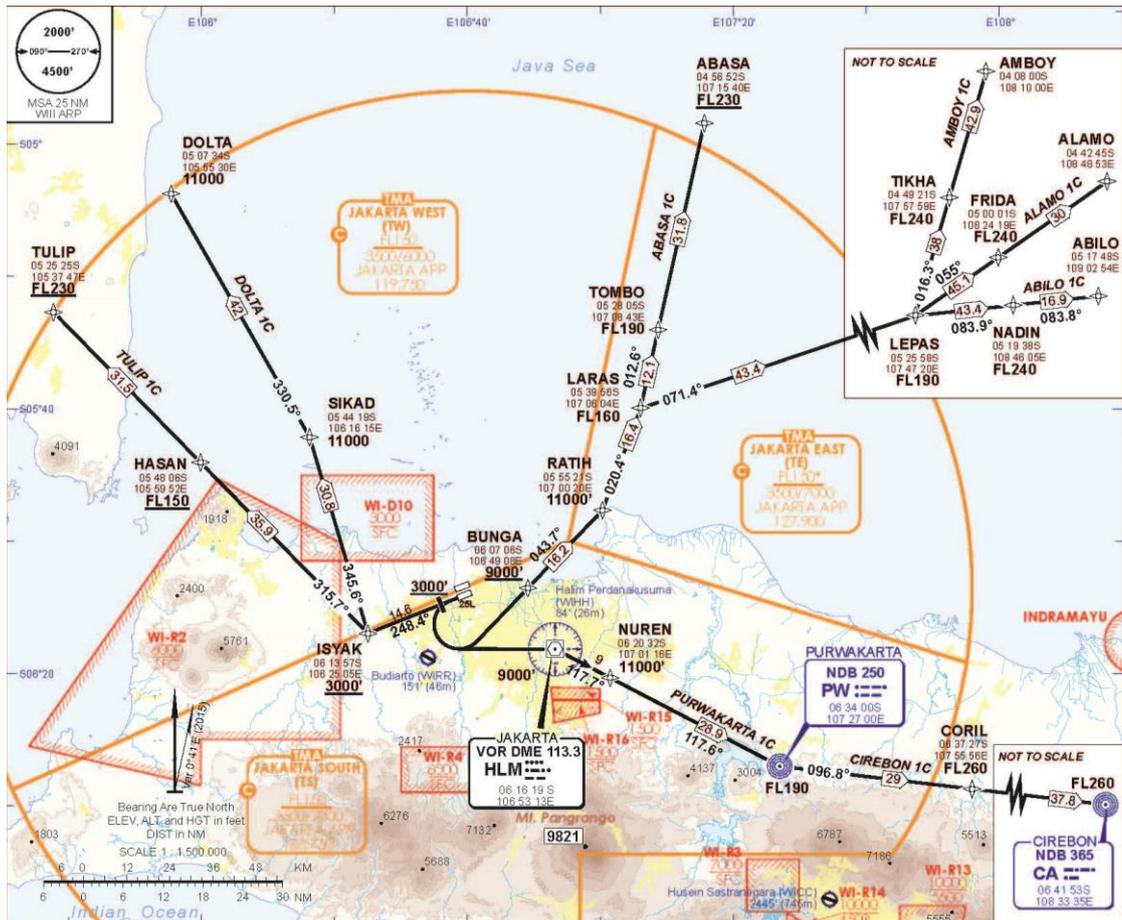
The runway 25L utilized RNAV-1 Standard Instrument Departure (SID), one of the SID was ABASA 1C which is after departure the pilot has to climb on heading 248.4°, at or above 3,000 feet then turn left direct to BUNGA – RATIH – LARAS – TOMBO – ABASA (figure 3).

Figure 3: The RNAV-1 runway 25L (extract from AIP Volume II)

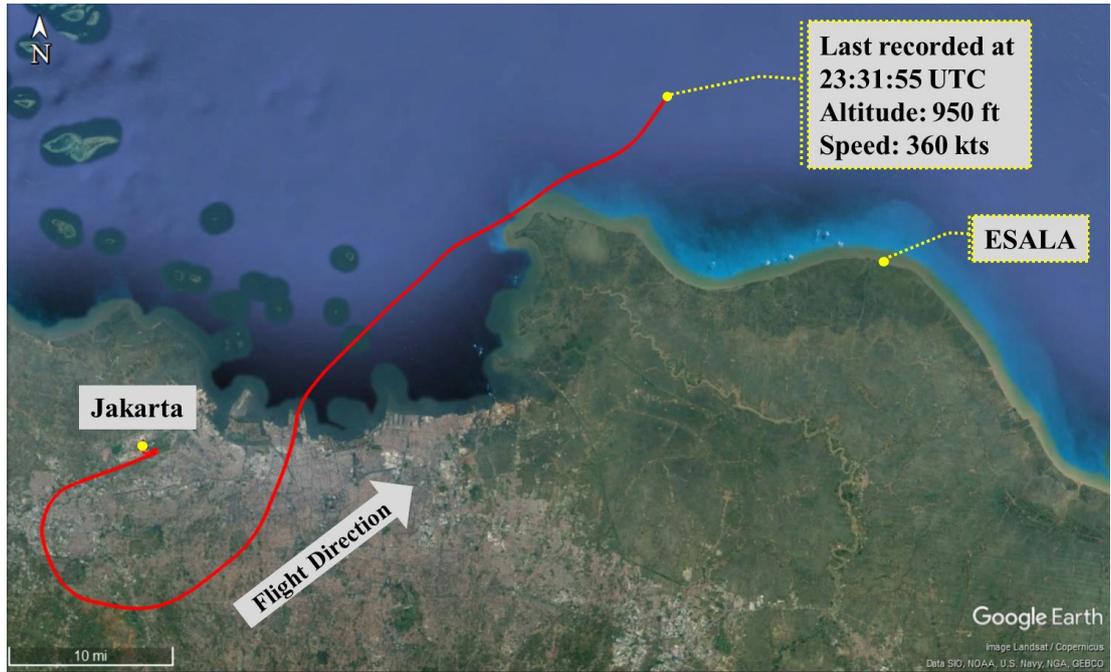
The flight track of the LNI610 based on the ADS-B data superimposed on Google Earth.

Figure 4: The flight track of LNI610 based on ADS-B

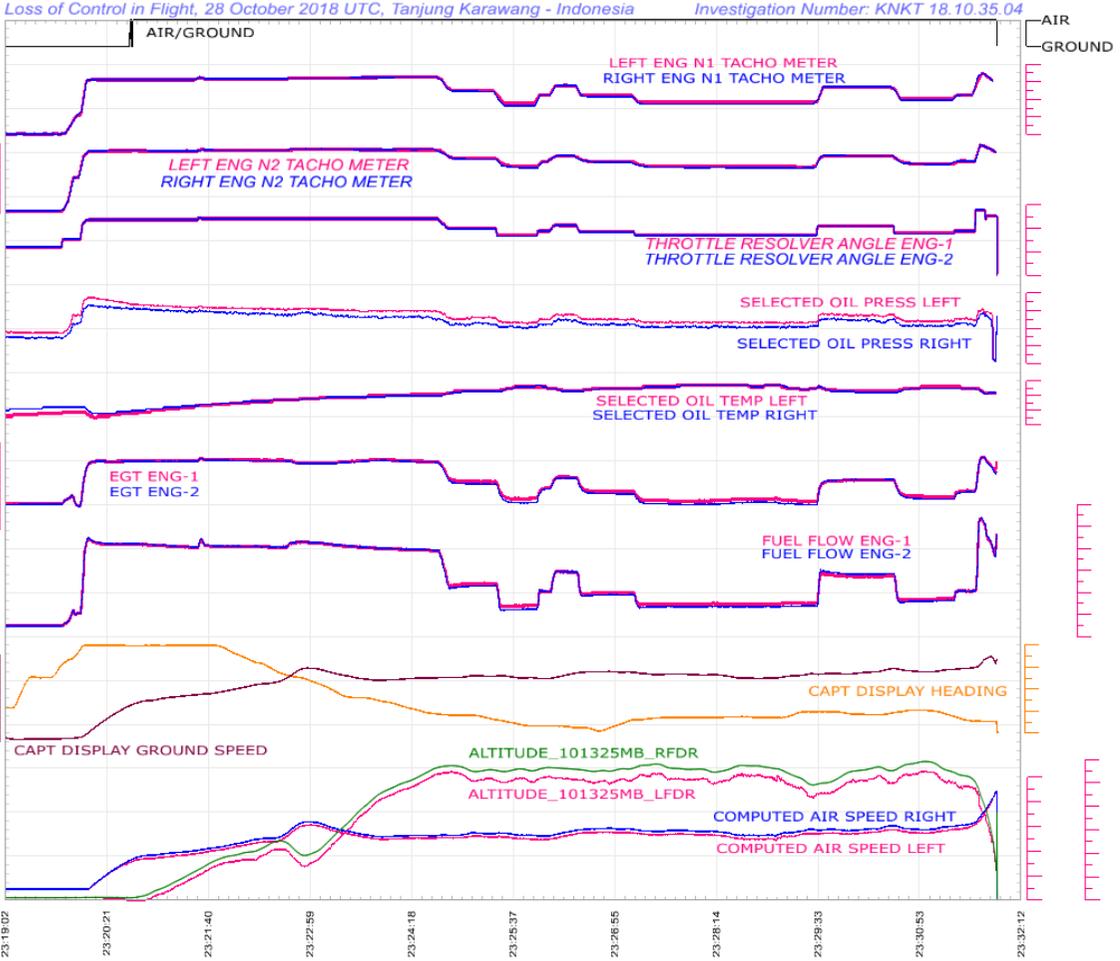
Figure 5: The significant parameters from the accident flight
